ULTRASONIC INSPECTION OF DAMAGE IN IMPACTED COMPOSITE PANELS

Sandris Ručevskis

Institute of Materials and Structures, Riga Technical University

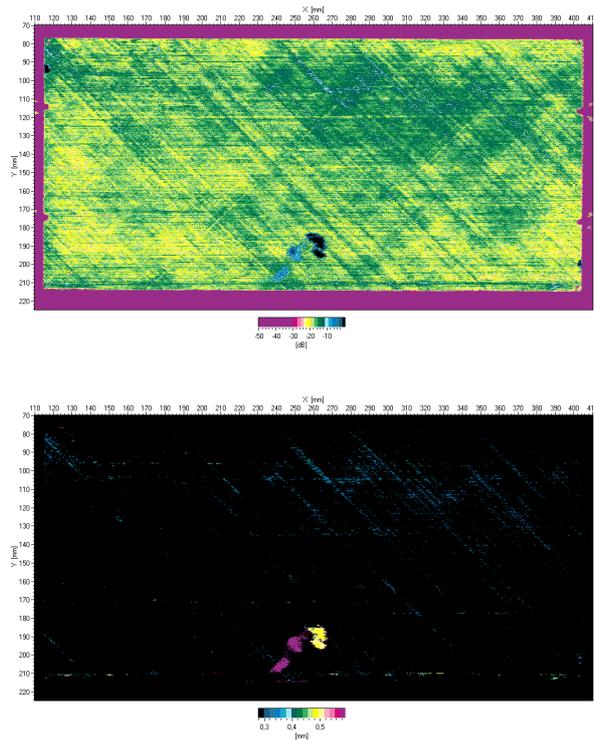
For the impact damage evaluation in composite panels, the C-scans of the flaw echo, backwall echo, and flaw depth were recorded. *Figures 7 and 8* show the results of ultrasonic imaging tests on panel 1 impacted at 10 J and panel 2 impacted at 15 J on the skin only. As seen from the C-scans, the damage consists of matrix cracks and delamination areas distributed in the lower layers directly at the point of impact and transferred to the free edge of the panel. The flaw depth image shows that most part of the delamination areas develops at adjacent interfaces of 45⁰ ply at the back surface. Additional imaging is possible with B-scans which clearly show the defects at different depth levels of the panels. An example is given in *Fig. 9* in the form of B-scan of panel 1 in the damaged area. A 15 J impact causes many echoes in the skin, which are displayed in the horizontal B-scan.

Fig. 7. C-scan images of panel 1: flaw echo (left) and flaw depth (right)

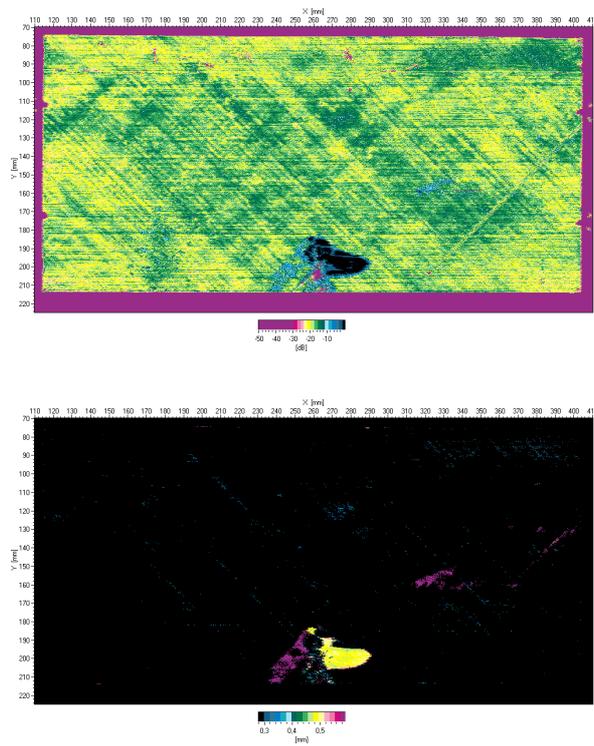
Fig. 8. C-scan images of panel 2: flaw echo (left) and flaw depth (right)

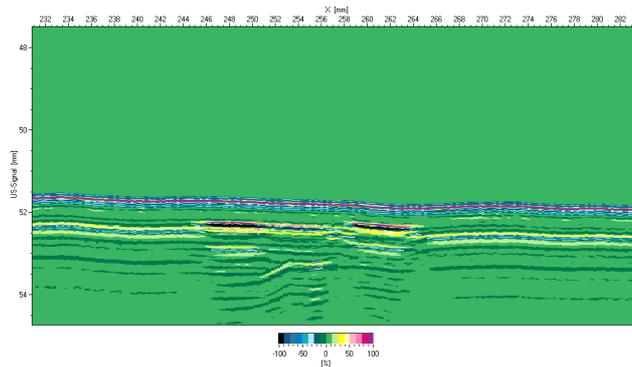
Fig. 9. B-scan image of panel 2

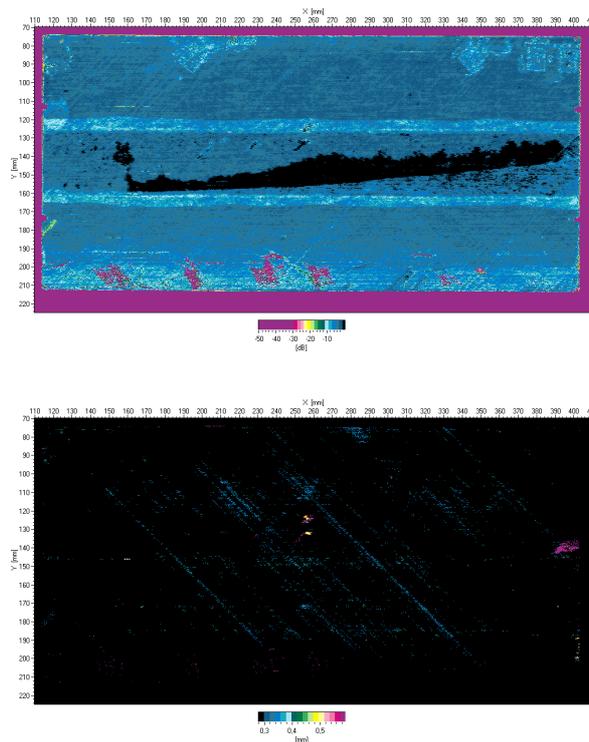
Fig. 10. C-scan images of panel3: backwall echo (left) and flaw depth (right)

Figure 10 presents the backwall-echo and flaw-depth C-scan images of panel 4 impacted at 15 J on the edge of stringer flange. As seen from the ultrasonic imaging results (flaw depth), matrix cracks and delamination areas arise in the lower skin layers at the point of impact. In this case, the damaged region is considerably smaller compared with the regions in the panels impacted on the skin only. This could be explained by the fact that most of the impact energy has been consumed by the process of skin stringer debonding, as seen from the backwall-echo C-scan image. Similar results were obtained for panels 3, 5, and 6.
