STUDY AND RENOVATION OF HISTORICAL MASONRY ARCH BRIDGE

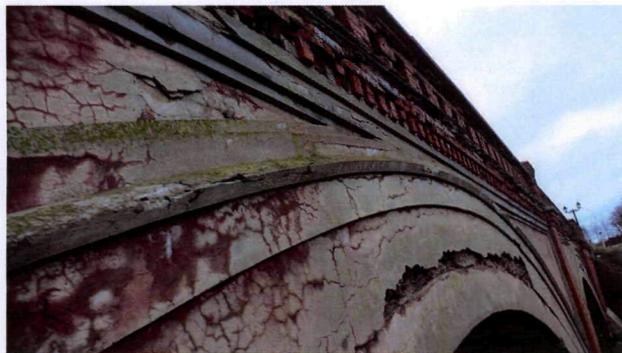
Fig. 5. Corroded and weathered bricks in wall surface from the upstream side

Inspection of the side wall masonry (1–5 spans) showed that the brick surfaces had corroded (weathered) in approx 40% of the surface from upstream side, and in 20% from the upstream side (Fig. 5).

It was recognized that from upstream side (South side) the brick surface scaling dominated, but from downstream side (North side) the weathering of cladding mortar dominated. Due to water filtration the leached mineral material is visible on the wall's surfaces.

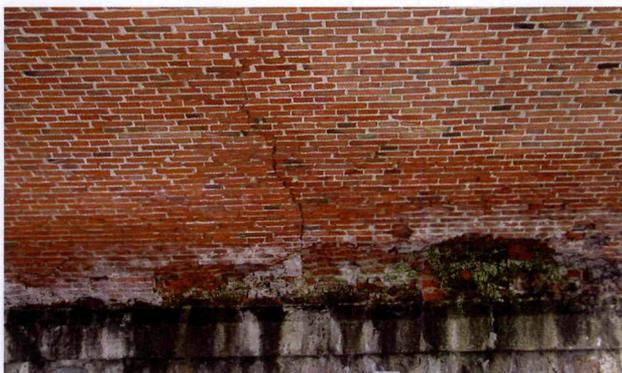
Fig. 6. Cracks and spalling in the reinforced concrete span surface

Inspection of the reinforced concrete side walls (span 6 and 7) showed that their technical condition is worse than that of the masonry sidewalls. It was recognized to have cracks in junction surfaces between precast wall elements and cast-in-place arched vault structure, partial plaster and concrete cracking and delamination (Fig. 6).

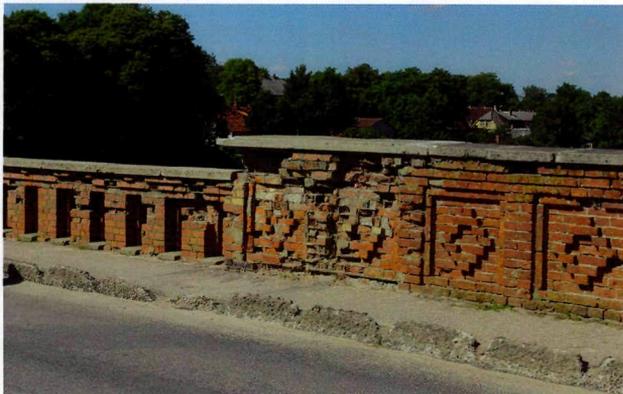
The parapets rebuilt in 1926 are heavily damaged. Approx 40% of all bricks are cracked or disintegrated (Fig. 8). The main reason thereof is low freeze/thaw resistance of the bricks and incorrect cladding material selection (Fig. 9).

Fig. 8. Serious brick damages in the parapet structure

Obtained results show that the bridge parapets could be restored to preserve the initial view, whereas the carriageway could be restored with cobblestone pavement.

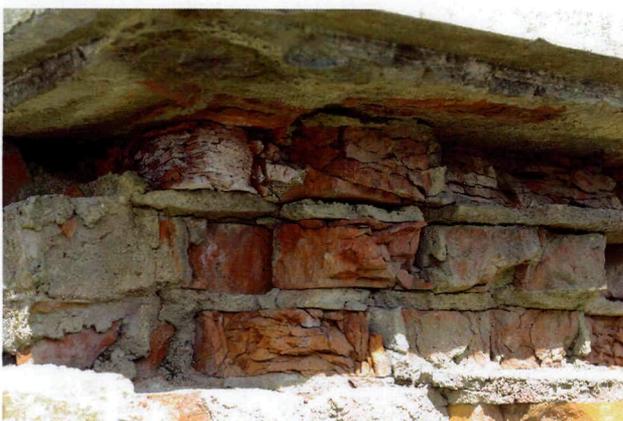
Fig. 9. Disintegrated bricks due to incorrect cladding material selection

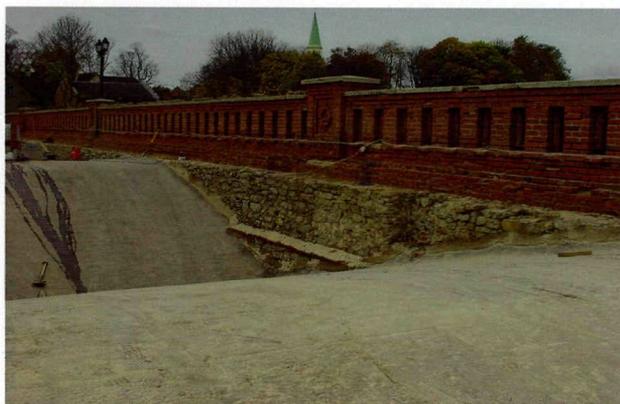
To verify the technical condition of overarch surfaces, it was decided to dig out the sand infill. The surface of brick arches was in good condition, old waterproofing and protection layers were still partly there (Fig. 10).

Fig. 10. Opened surfaces of brick arches showed remaining waterproofing and good technical condition

Therefore, the most necessary tasks were to restore waterproofing and fill the overarch part with draining sand.

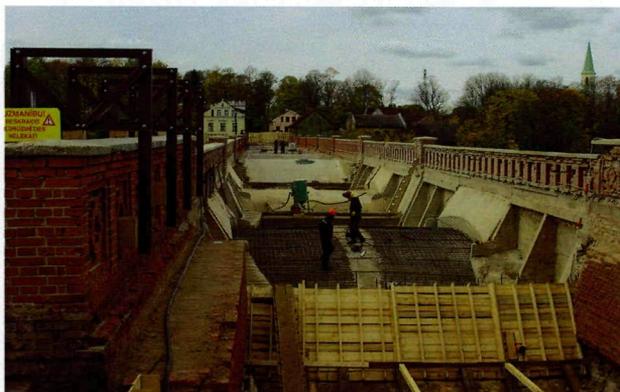
Fig. 11. Strengthening of the reinforced concrete arch span

The surfaces of reinforced concrete arches have no large damages or cracks. The calculation showed that the load carrying capacity of the reinforced concrete arches was reasonably good. Therefore, it was planned to strengthen them with additional reinforced concrete arches placed over the existing (Fig. 11). New waterproofing layer

was provided on the arches and inside parts of the walls. The design provided back-of draining sand between the side walls.
