Restoration of masonry arch bridge over Venta River in Kuldiga

Andris Paeglitis, M.Eng. Ph.D.student, Riga Technical University, Address: Azenes st. 20, Riga, LV1048, Latvia. E-mail: andris.paeglitis@inzenierbuve.lv

Ainars Paeglitis, Professor , Dr.sc.ing., Riga Technical University, Address: Azenes st. 20, Riga, LV1048, Latvia. E-mail: paeglitis@apollo.lv.

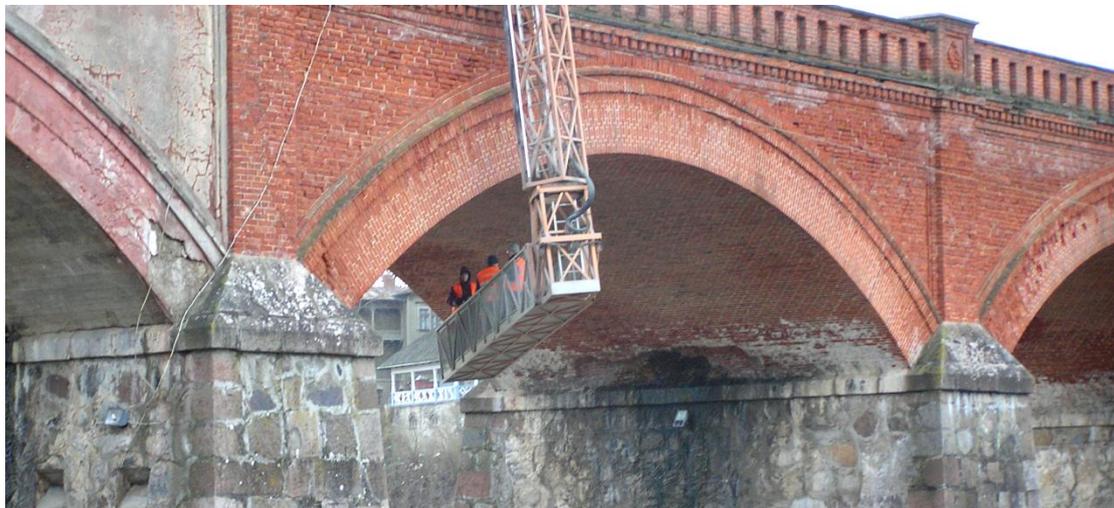
Fig. 2: View of the fifth arch in 2006 inspection

The inspection carried out in 2006 showed several deteriorations in masonry wall and arch structures. There were found in bricks, some stones had crumbled away in piers, cracks in reinforced concrete (Fig. 2).

During the inspection was found that hydro insulation and drainage of surface water had been damaged due to long term use, and it had caused crumbling of water filtration in bricks through the surface of arches and side facades. Brick corrosion, crumbling of joint materials due to long-term water filtration could cause the loss of bridge’s carrying capacity.

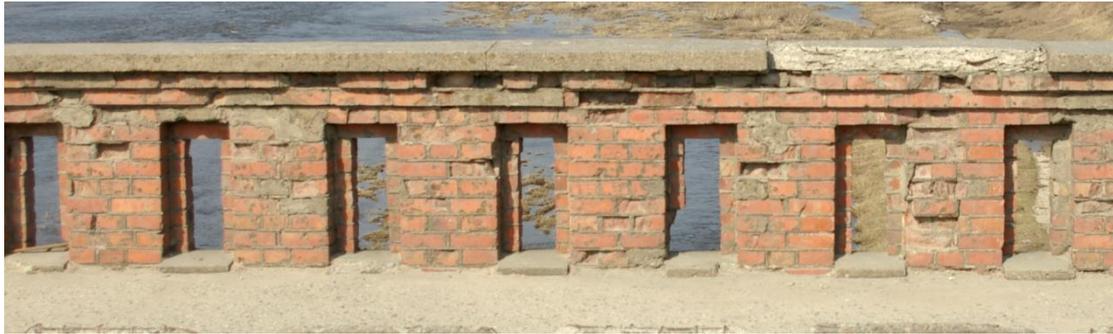
Fig.3: View of new parapet built in 1926

The use of soft bricks with lime based mortar (as in structure from 1874) allow the water migrate in masonry and did not rise the damages. The use of cement based mortar for joints with soft bricks (as in structure from 1925) accumulate the water in bricks and the frozen water destroys the brick from inside (Fig.3). The obtained results allow taking right decisions by restoration and upgrading.

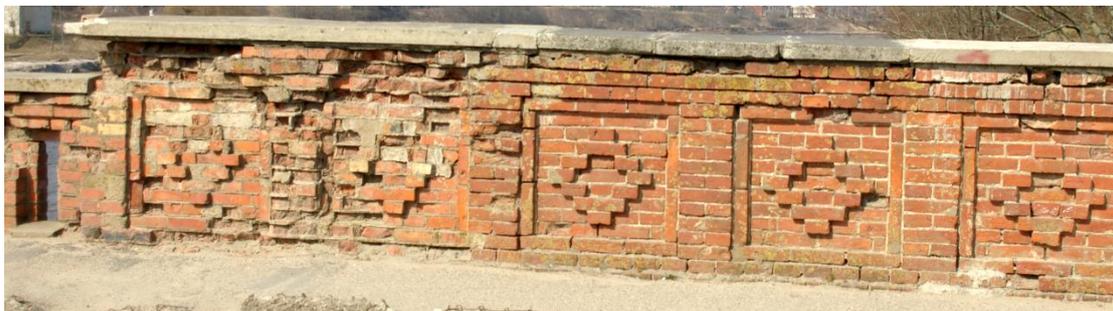
Fig. 4: Bridge parapet (on the left side the one built in 1926 and on the right old one)

When working out the restoration project, very careful research had been done on the bridge. Stone Conservation and Restoration Center (Dr. Inta Vitina) of Riga Technical University was asked to research bricks and mortar. Tests of physical features of stones showed that all historic bricks had a high level of porosity and water absorption. The reinforced concrete tests had considerably lower quality. It is important to show that indicators of porosity of dolomites and water absorption are similar to brick indicators. It means that dolomite is compatible with bricks and ensures the right *breathing* to the brick wall. But the brick wall fixed with cement mortar and ferocious concrete are not compatible with historic bricks and historic dolomite grout, because it makes exudation of dampness and *breathing* of the brick wall harder. Such combination of materials stimulates corrosion of bricks especially in places where the stone wall of 1926 had been renovated with the cement mortar. It is clearly visible when compare the technical condition of original and renovated in 1926 parapets (Fig.4).

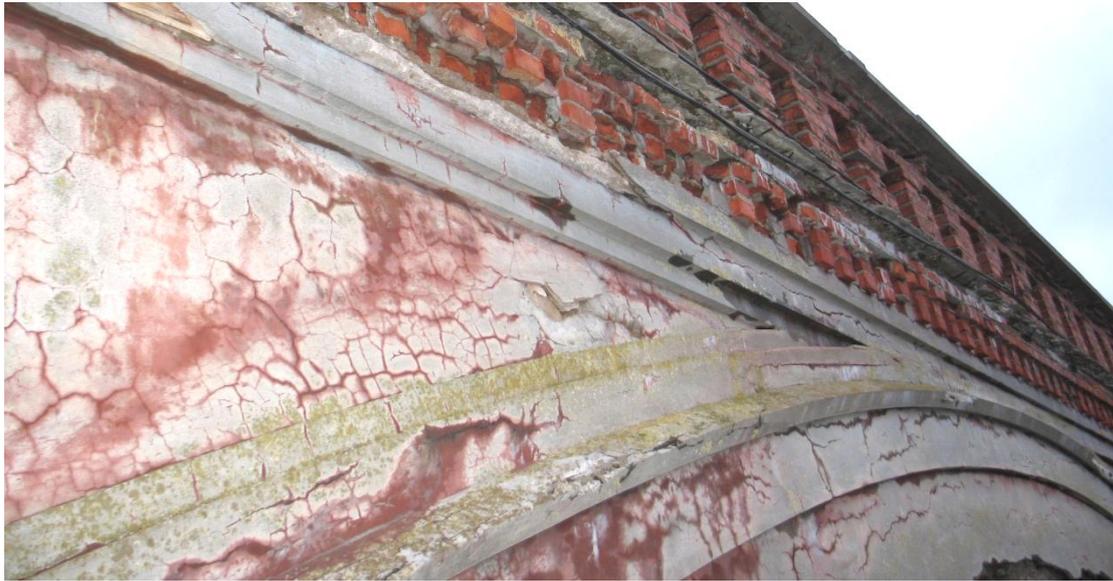
Fig.5: View of reinforced concrete arch

Chemical tests of salt pollution of bricks, reinforced concrete, dolomite stone and the old dolomite grout indicate that the level of the salt soluble in water is very low and does not correspond to criteria of unsalted brick walls although before the cleaning of the bridge in 2001 signs of white salt could be found. The reason for that might have been Calcium Carbonate (CaCO_3) that usually appears on historic monuments because of water migration through bricks, undermining Calcium Hydroxide out of grout and mortar. When the drying Calcium Carbonate carbonizes on the brick surface it creates insoluble Calcium Carbonate that can be cleaned by heavy water or sand jet only thus increasing the brick corrosion because the natural protection layer is getting damaged. The pH level that was found in

reinforced concrete is 8.5 and 9.3 thus showing signs of corrosion created by carbonization(Fig.5).

The research allowed working out renovation tasks of the bridge – the damaged bricks should be changed with bricks of the same quality utilizing the cleaned old bricks from buildings of the same time or making use of the brick *Sencis* that is produced in factory Lode after the old mixing formulae. Disintegrated and mechanically weak brick surface should be cemented and wholes should be filled with special restoration mortar. Cement mortar should not be used for brick joints. The best one is dolomite grout with 5-10% Portland cement as a binding material.

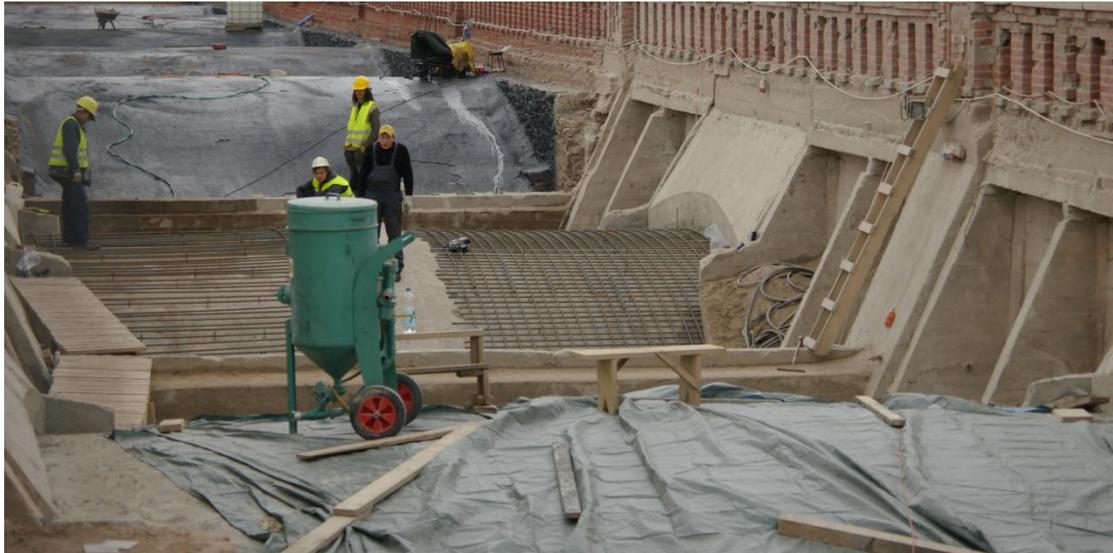
Fig.6: View of concrete arches

The first thing to do is to dismantle the road surface and to dig out the filling of arches in order to see the technical condition of the bridge. After the digging up of the filling had been done it was possible to see that the bridge is in good condition – the surface of reinforced concrete did not have big damage or cracks. But for our traffic intensity the carrying capacity was not good enough, therefore it was planned to reinforce it by building steel framework for arches 6 and 7(Fig.6).

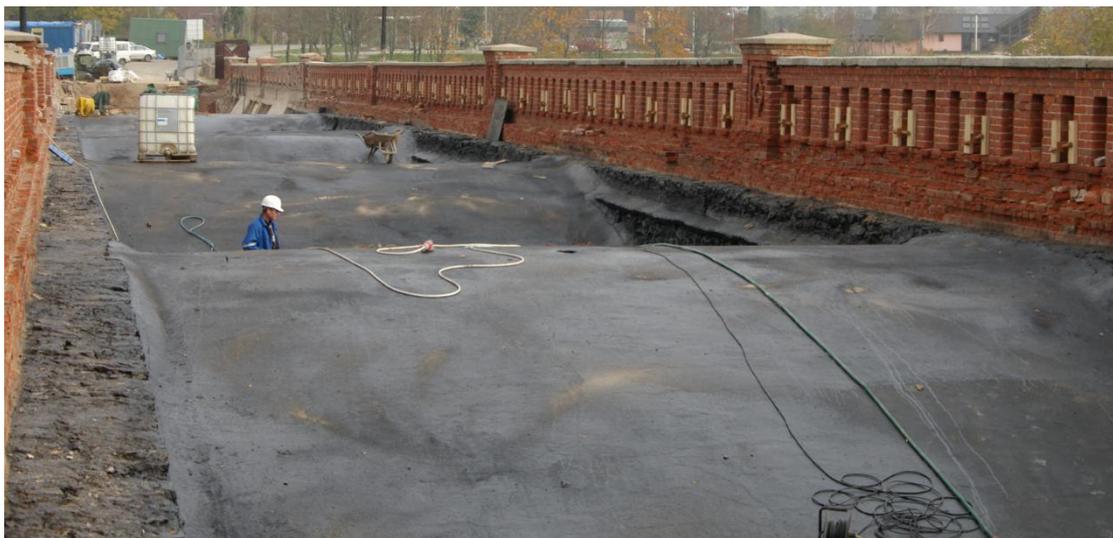
Fig.7: New waterproofing

The surface of brick arches was in good condition, old waterproofing and protection layers were still partly there. Therefore the most necessary tasks were to restore waterproofing (Fig.7) and fill the arches with draining soil.
