# PREDICTION OF CONCRETE BRIDGE DETERIORATION CAUSED BY DE-ICING SALTS IN LATVIA

Kristaps Gode<sup>1</sup>, Ainārs Paeglītis<sup>2</sup>

<sup>1,2</sup>Rīga Technical University, Rīga, Latvia

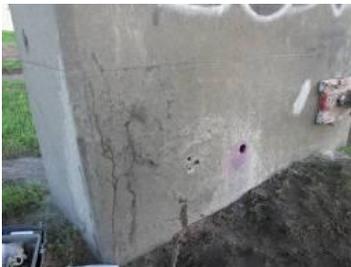
Core drilling was performed, and core samples were obtained from different pier surfaces and positions. Approach ramp No.8 pier is on the outside of highway with the widest surface facing towards traffic at a 31 degree angle. Reinforcement corrosion cracks were detected at the corner closest to the road (Fig.4). Core drilling was performed at 83 cm away from the corner and 33 cm above the ground surface. A second core sample was taken from another side of this surface (Fig.5).

**Fig. 4.** Reinforcement corrosion cracks at the pier corner.

mm the chloride concentration is close to critical value of 0.4%. Since no corrosion was detected, it can be assumed that reinforcement corrosion threshold value is at least 0.4% or greater. Both profiles and the fact that there are reinforcement corrosion cracks at the pier corner, which is the closest to highway, show that chloride distribution is greatly influenced by the distance from the road and the angle at which the pier surface is facing traffic. Profile P5-1 was obtained from approach ramp No.5 pier's surface facing traffic, and is very similar to P8-1 profile. Other profiles from the surface facing away from the traffic show significantly less chloride concentration. Profile P5-2 which was obtained from the position a little lower than from profile P5-3 shows a bit more chloride concentration. The concrete cover depth of this surface was measured 60 mm. The profiles P7-1 and P7-2 were obtained from the both piers surfaces of the approach ramp No.7 facing towards and away from the traffic. Both show low levels of chloride concentration and cracks of reinforcement corrosion close to highway were not assessed. This convinces us that chloride concentration in the road environment is very variable.

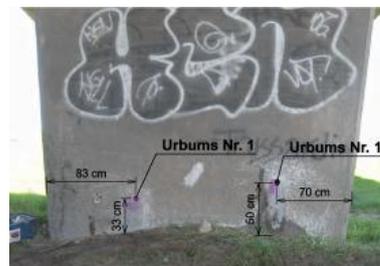
**Fig. 5.** Core sampling from the ramp No.8 pier.

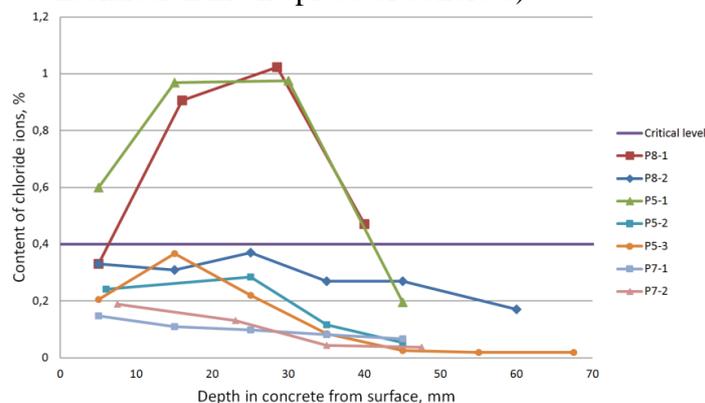
**Fig. 7.** Chlorides in cement paste of bridge piers.

From Figure 14 we can see that the amounts of chlorides vary greatly at different depths in concrete and in different places of the structure. In depths under about 15 mm the chloride content is low. This shows that chlorides closer to the surface were washed out. The profiles with the highest chloride concentration (samples P8-1 and P5-1) were found from surfaces facing toward the traffic direction and closer to the corner of the pier. The profiles (P8-1 and P8-2) from the approach ramp No.8 piers were obtained from the same surface facing towards traffic. Profile P8-1 shows much greater chloride concentration, because it is much closer to the road. At the reinforcement depth 42

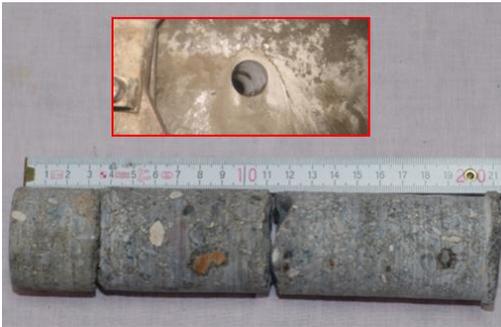
For the bridge over Bieķengrāvis we investigated corrosion initiated by de-icing salts that reach structure surfaces through leaking expansion joints. The core samples (Fig.8) were obtained from the web of the beam near the tail end of it (sample P2 and P3) and from the cap beam side surface bellow the leaching joint (sample P1). The chloride profiles from obtained samples are shown in Figure 9. The investigated web part of the beam did not have significant moisture signs. It was technically impossible to take the sample at very tail end of the beam, which might have a higher moisture exposure. The investigated cap beam surface that is located below expansion joint has been exposed to moisture and de-icing salts.

**Fig. 8.** Core sample from the web of the beam near leaking expansion joint

The investigation shows that chloride levels are low for the bridge over Bieķengrāvis. The concentration of chlorides in the vertical surface of the cap beam show greater amounts in the top layer, but it is sufficiently low so as not to cause reinforcement corrosion in the foreseeable future. The concrete of the girder and cap beam are of very good quality. The chloride level in the bridge beam close to the leaking joint, but not directly exposed to chlorides, also is very low. The corrosion risk exists only for surfaces with direct chloride exposure, such as horizontal surfaces on the bottom part of the cap beam. Investigation showed that parts below leaking joints at several places have severe reinforcement corrosion. Chloride profiles for Riga bypass A5 Bridge over the Daugava show that in general the chloride concentration level is not high and will not initiate intensive primary reinforcement corrosion. Higher amounts of chlorides are found in depths to 10 mm. At depths of 10 – 60 mm, the chloride content is more or less constant and is not reducing, which means that the girders have relatively high initial chloride concentration, varying between 0.19% and 0.25%, on average 0.22%. This high chloride concentration could not accumulate during the service life (especially for sample P3), where the girders have not been exposed to intensive and long-term moisture influence. Chloride profiles for samples P1 and P2 show higher concentration at depths of 40 – 60 mm because the sample was obtained near the tail end surface of the girder (P1 – 12 cm and P2 – 6.5 cm from the tail end surface). Most likely these chlorides entered the concrete from the tail end surface which is situated right beneath the expansion joint. Visual inspection detected damage to the tail end surface of the girder, showing that there the chloride concentration is a lot higher and reinforcement corrosion is advancing. Reduced chloride amounts near the surface are likely to be washed out by water not containing chlorides during summer rains. Taking into account that girders have relatively high initial chloride concentration – on average 0.22% (usually it is about 0.1% (Lay, S., Schiessl, P., 2007)) the additional chloride needed to initiate corrosion should be a lot less. This means that these structures should not be exposed to de-icing salts for longer periods of time. In cases of expansion joint or waterproof membrane damages it would be necessary to stop applying de-icing salts and repair damage to prevent chlorides reaching girder surfaces.

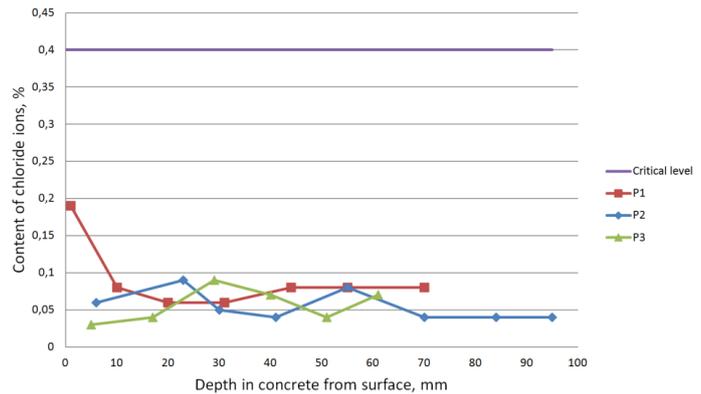
**Fig. 9.** Chloride profiles for the Bridge over Bieķengrāvis.

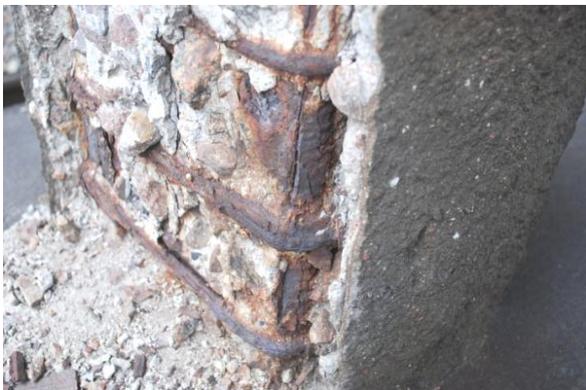
The bridge has deteriorated and also has leaking waterproof membrane beneath tram lines (Fig.11). During inspection it was stated that corrosion of reinforcement bars in the beams is developing, which is causing the concrete cover to crack and delaminate. Two samples for chloride investigation were obtained from the bottom part of the beam near reinforcements. This bridge also has leaking joints that cause chlorides to reach surfaces of the piers (Figure 10). During inspection severe corrosion of the bridge piers towards the bottom were noted. The third sample obtained from the bottom part of the pier showed very high chloride content (Table 1). It should be noted that the inspection took place at the end of the summer season where most of the chlorides from the surface were washed out.

**Fig. 10.** Corrosion of reinforcement.

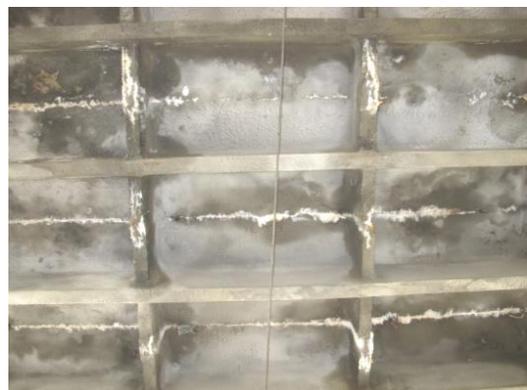
**Fig. 11.** Signs of leaking and deteriorated membrane.

The main reason for corrosion deterioration of the bridge over the railroad “Gaisa tilts” is leaking waterproof membrane and also leaking joints. The leaking membrane is below tram lines, which makes them difficult to repair and it is obvious that they have not been repaired for very long time. The leaking waterproof membrane causes girders to have a high moisture level throughout the year and chloride contained moisture during winter. Corrosion damage usually appears on the bottom

part of the beam and is spread within the whole span, which could cause the loss of structural bearing capacity in the middle of the span.

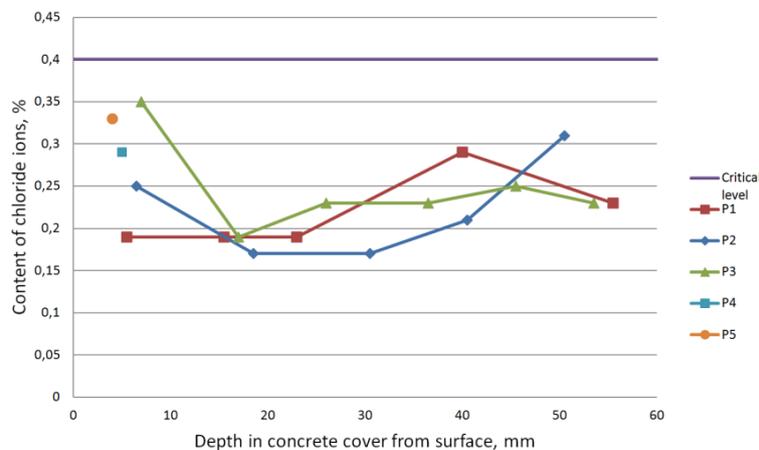
**Fig. 14.** Chloride profiles for Bridge over the river Daugava on bypass A5.

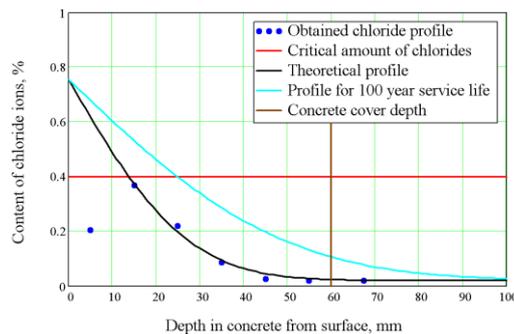
The profile P5-3 corresponds closely to the theoretical profile (Fig. 15). The future profile for 100 year service life is calculated by extrapolation. From figure 15 it can be seen that the critical concentration of chlorides at which corrosion may start has not reached the depth of reinforcement.

**Fig. 15.** Calculation of chloride profiles (profile P5-3) at deterministic level.

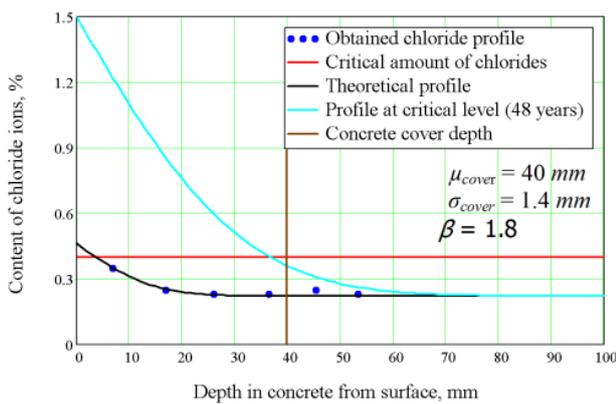
**Fig. 16.** Calculated chloride profile for 40 mm concrete cover in a case of a higher chloride exposure.
