CONCRETE BRIDGE DETERIORATION CAUSED BY DE-ICING SALTS IN HIGH TRAFFIC VOLUME ROAD ENVIRONMENT IN LATVIA

Kristaps Gode¹, Ainars Paeglitis²✉

Institute of Transport Infrastructure Engineering, Riga Technical University, Kaļķu str 1, LV 1658 Riga, Latvia

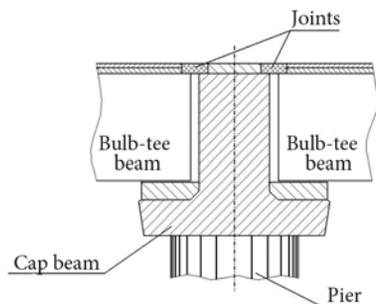
Fig. 5. Support structure of the bridge

The bridge above each pier has two joints, which are the weak point of these type structures (Fig. 5). Leaking joints may cause reinforcement corrosion damage to cap beam and tail-end parts of the prestressed bulb-tee beams.

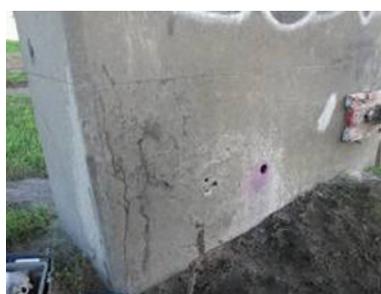
Fig. 8. Reinforcement corrosion cracks at the pier corner

angle. Reinforcement corrosion cracks were detected at the corner closest to the road (Fig. 8). Core drilling was performed at 83 cm away from the corner and 33 cm above the ground surface. A second core sample was taken from another side of this surface (Fig. 9).

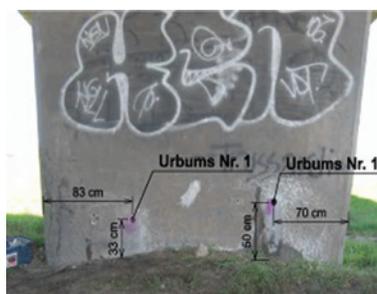
Fig. 9. Core sampling from the ramp No. 8 pier

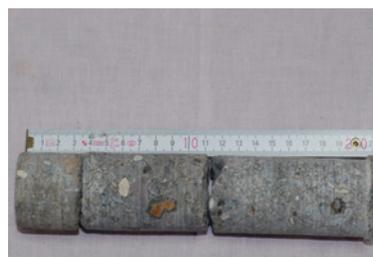
For the bridge over Biekengrāvis we investigated corrosion initiated by de-icing salts that reach structure surfaces through leaking expansion joints. The core samples (Fig. 12) were obtained from the web of the beam near the tail end of it (sample P2 and P3) and from the cap beam side surface bellow the leaching joint (sample P1). The chloride profiles from obtained samples are shown in Fig. 13. The investigated web part of the beam did not have significant moisture signs. It was technically impossible to take the sample at very tail end of the beam, which might have a higher moisture exposure. The investigated cap beam surface that is located below expansion joint has been exposed to moisture and de-icing salts.

Fig. 12. Core sample from the web of the beam near leaking expansion joint

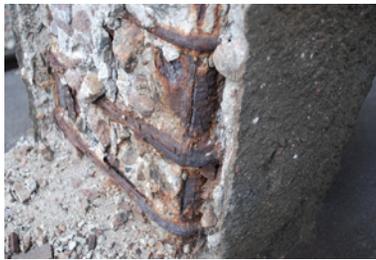
The bridge has deteriorated and also has leaking waterproof membrane beneath tram lines (Fig. 14). During inspection it was stated that corrosion of reinforcement bars in the beams is developing, what is causing the concrete cover to crack and delaminate. Two samples for chloride

Fig. 14. Corrosion of reinforcement

(Fig. 14). During inspection severe corrosion of the bridge piers towards the bottom were noted. The third sample obtained from the bottom part of the pier showed very high chloride content (Table 1). The inspection took place at the end of the summer season where most of the chlorides from the surface were washed out.

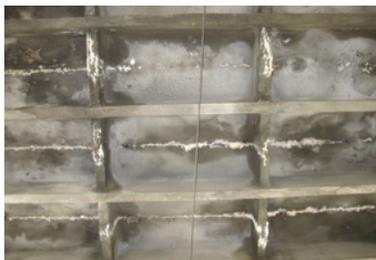
Fig. 15. Signs of leaking and deteriorated membrane

The main reason for corrosion deterioration of the bridge over the railroad “Gaisa tilts” is leaking waterproof membrane and also leaking joints. The leaking membrane is below tram lines, which makes them difficult to repair and it is obvious that they have not been repaired for very long time. The leaking waterproof membrane causes girders to have a high moisture level throughout the year and chloride contained moisture during winter. Corrosion damage usually appears on the bottom part of the beam and is spread within the whole span, which will cause the loss of structural bearing capacity in the middle of the span in the future.

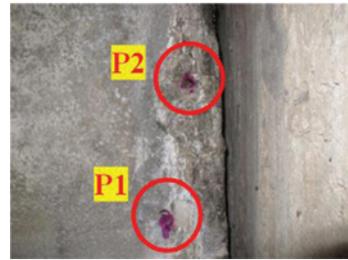
Fig. 16. Locations of samples P1 and P2 for bridge over the Daugava on bypass A5

As this bridge has leaking expansion joints, samples P1 and P2 were obtained from the tail end of the beam near a leaking joint where moisture was obvious (Fig. 16) and samples P3, P4, P5 from the position where no moisture or chlorides (signs) were present (Fig. 17). The inspection also took place at the end of the summer season where most of the chlorides from the surface were washed out. The samples were obtained by concrete drilling at different depths from the surface and collecting the concrete powder. The obtained chloride concentrations and chloride profiles are shown in Fig. 18.

Chloride profiles for samples P1 and P2 show higher concentration at depths of 40–60 mm because the sample was obtained near the tail end surface of the girder (P1 – 12 cm and P2 – 6.5 cm from the tail end surface). Most likely these chlorides entered the concrete from the tail end surface which is situated right beneath the expansion joint.

Visual inspection detected damage to the tail end surface of the girder, showing that there the chloride concentration is a lot higher and reinforcement corrosion is advancing. Reduced chloride amounts near the surface is likely to be washed out by water containing no chlorides during summer rains.

needed to initiate corrosion are a lot less. This means that these structures need to avoid being exposed to de-icing salts for longer periods of time. In cases of expansion joint or waterproof membrane damages it would be necessary to stop applying de-icing salts and repair damage to prevent chlorides reaching girder surfaces.
