Pavels GAVRILOVS*, Viktors IVANOVS

Riga Technical university, Institute of Railway Transport
Azenes street 12, LV-1048, Riga, Latvia

RESEARCH OF THE DEFECTIVE FROG WING OF 1/11 MARK

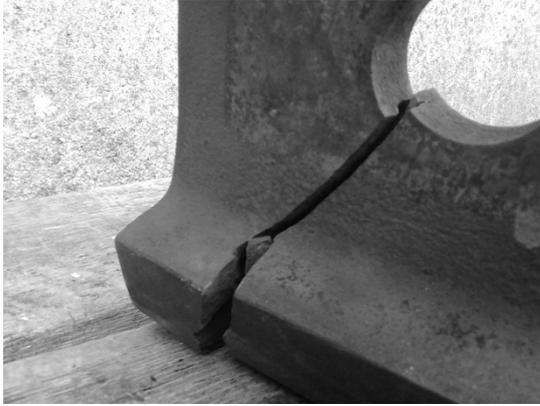
The defect code U.53. (Fig.5) is classified in the wing as cracks in the web from bolted or other holes in the rails and frog wings. Accordingly, the defect code U.53. is subdivided into the defect code U.53.1. and U.53.2., which means that U.53.1 is a defect of the wing in the joint and U.53.2 is a defect of the wing located outside the joint. Head chocks (small cracks) at the edges of the holes caused by drilling and corrosion accelerate the formation of a crack. The unsatisfactory condition of joints (weakening of bolts, subsidence in joints, the presence of large gaps) may be the main reason for the appearance and development of this type of defect [13].

The aim of this research was to study the broken defective frog wing of the 1/11 mark with the defect code U.53.2., type of the frog 60 E1 DO 04 07, rail type UIC 60, produced by Dowlais Steel Works [6] in April 2007. This specimen of the wing of the third bolted hole (Fig. 6) was broken from the frog throat to the entry points No. 1 of the Sece station of the Latvian Railway.

Fig. 5. The cut specimen of the wing under the defect code U.53.2

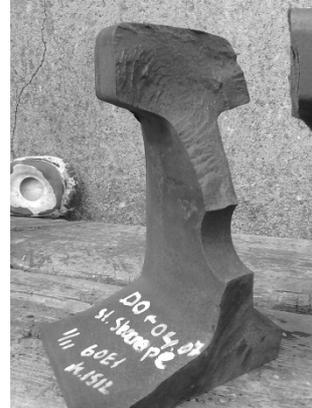
Fig. 6. The part of the cut broken wing (end view)

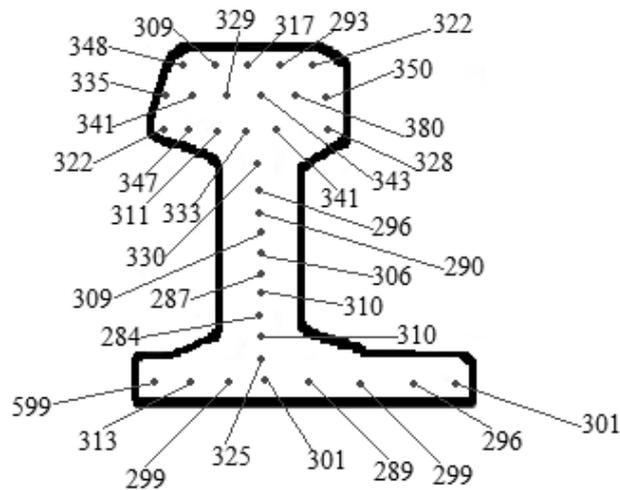
Fig. 7. Determination of hardness of the frog wing of the 1/11 mark with frog type 60 E1 DO 04 07 in HB:
 at the wing top: 348, 309, 317, 293, 322, 335, 341, 329, 343, 380, 350, 322, 347, 311, 333, 341, 328.
 in the wing web: 330, 296, 290, 309, 306, 287, 310, 284, 310, 325.
 at the wing base: 599, 313, 299, 301, 289, 299, 296, 301.

The average hardness in the wing top was 322 HB, which is 47 HB less than the permissible value of the manufacturer [8]. During testing, the medium hardness in the wing web was 305 HB, which is 73 HB less. Based on the results obtained, the average hardness in the base was 337 HB, which is 51 HB less than the specifications of the Austrian manufacturer [10].

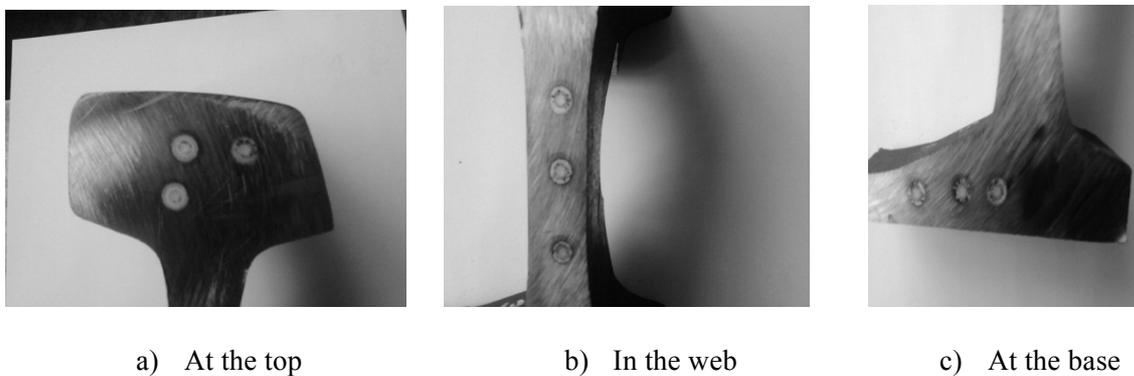
Fig. 8. Determination of the chemical composition in the three elements of the wing

On comparing the basic, permissible values of chemical elements of the composition of rail steel, the following conclusion can be drawn: the carbon (C) content is greater by 0.089% than the manufacturer's specification.

The results of the researches showed that the content of (Mn) manganese was normal. The chemical element silicon (Si) was in the permissible percentage ratio. The chromium (Cr) content was higher than the established value, with a standard value of 0.0129%. The percentages of chemical elements such as phosphorus (P) and (S) sulfur were not within the allowable limits. The percentage of phosphorus (P) was more at 0.067% and the percentage of sulfur (S) was more than 0.0186%. The percentage value of such chemical elements as nitrogen (N) was not determined during the researches. The content of aluminum (Al) had increased by 0.0003% [5].

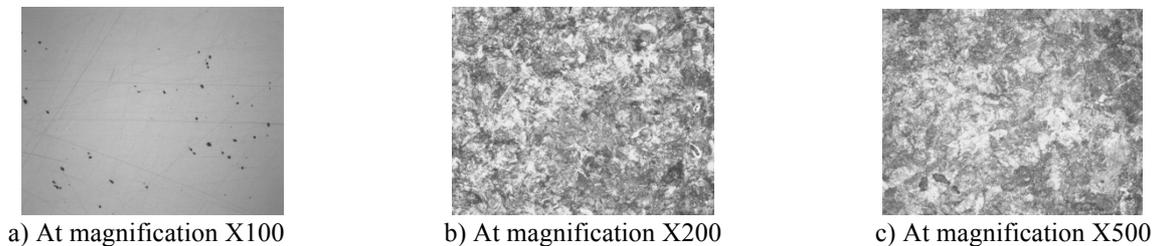
The obtained researches are shown in Fig. 10. As can be seen from Figure 10 (a), inclusions in the form of black spots were found in the metal structure. It can be assumed that the cause of the fracture was the presence of many inclusions in the metal because these inclusions could be a “nucleus” of the formation of cracks.

The metal structure was ferrite–pearlite. The ferrite–pearlite structure is a mixture of ferrite and cementite.

Fig. 9. Determination of the metal structure under a microscope at different magnifications
