Some features of behavior of acoustic emission signals at dynamic bench tests of prestressed concrete sleepers

To quantify the fracture loads of railway prestressed concrete sleepers the dynamic bending tests were carried out. In the course of tests the initial (first) crack, the crack opening and crash event of prestressed monobloc sleepers were registered by a Method of Acoustic Emission (MAE). It is shown that MAE allows to fix the beginning of cracking and evolution of cracks earlier, than other instrumental and visual inspection. During visual inspections (no longer than 5 min between the dynamic loading steps) for crack shores opening measurement the cracks are "healing". This effect it is clearly seen by the Acoustic Emission signals movement on the next loading step. The cracs "curing" time is reduced from one load step to another. The received results will allow to define further quality of clutch of armature with concrete, and as consequence, quality of pulling together efforts of any preliminary intense reinforced concrete designs

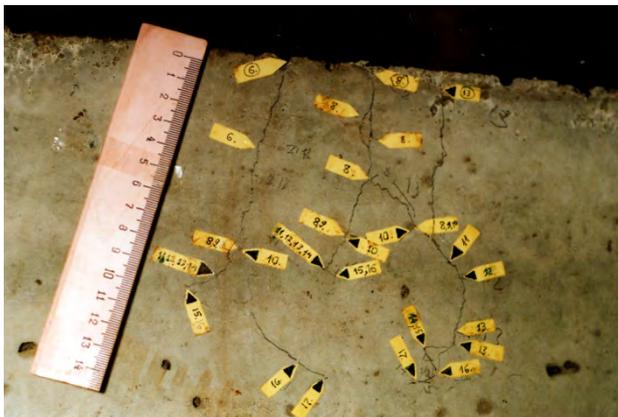
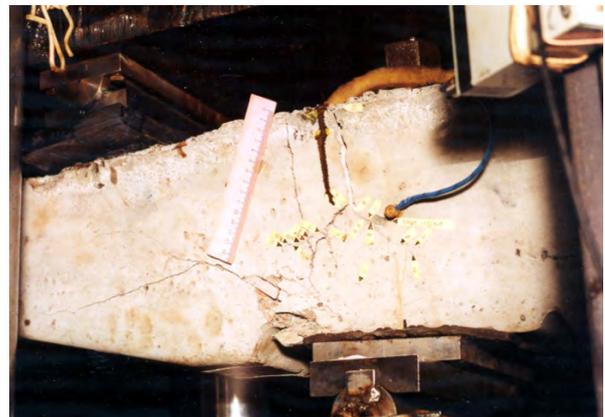
Fig.5. Kind of cracks on the lateral surfaces of the sleepers I after being subjected to 17th stage. A): current cracking, B) the sleepers fracture (it is AE gauge is seen on the side of the sleeper)

It is seen that on the right side of the sleepers in the upper part of the surface formed three independently developing cracks. On the left side surface formed a crack. These cracks were detected only when the sleeper was under dynamic load during the test. In the process of visual inspection with no load time to crack "heal" and as a consequence of residual reducing valves and effort they are not visually detected. Detection of cracks with no load began only after the branching (indicated nameplates - arrows with shading). The number on the label must (arrows) indicates the number of stages of dynamic loading. On the 18 th stage Sleepers destroyed.

Destruction of sleepers № № 1,2,3 happened during the dynamic load of 250 ± 200 kN at the 18th stage (see Fig.6,7,8,9.) The destruction of sleepers number 4 occurred at the 14th stage with a load of 200 ± 150 kN. Visual inspection during routine inspections according to the standard [2] discovered the appearance of cracks with the disclosure of the crack on the value of 0,05 mm in the sleeper number 1 after the 8th stage of dynamic loading. At sleepers № № 2,3 - after a 15th, and the sleeper № 4 crack formation with a wide opening to the end of the fracture was not detected (revealed only the disclosure of 0,01 mm with a load of 170 ± 120 kN for the 10th stage). At Fig.5 as an example, shows a photograph of sleepers № 1, taken after the 17-th stage of loading and it's fracture.
