Janis Zilgalvis

ARCHITECTURAL AND HISTORICAL RESEARCH OF NAUKŠĒNI MANOR

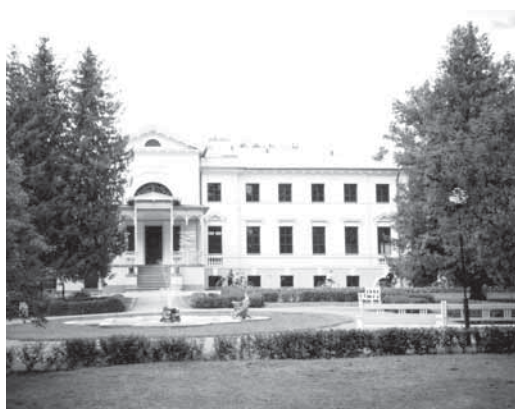
Figure 3.

The manor house of Naukšēni (Photo by Zilgalvis)

After dividing the heritage in 1836, the manor was managed by a son of F. von Grote, Heinrich Wilhelm von Grote (1797-1878). In the meantime, building master Friedrich Gotlieb Gläzer from the town of Cēsis finished the construction of the new manor house of Naukšēni² in 1843. The influence of German empire architecture is apparent in the new building (Figure 3).

Naukšēni manor suffered heavily during the war in 1919. At the end of 1919 the Ministry of Agriculture took over the manor under its auspices. In 1930 the manor house served as a state educational and correction facility. The building was rebuilt in 1938 in line with the design by architect Arnolds Čuibe, which led to destroying the historical interior. After the World War II, Naukšēni manor house served as an orphanage, and later from 1957 until the end of the Soviet period served as a vocational technical school. The reconstruction project of the manor house designed in 1998 turned the building into the Naukšēni educational and correctional establishment with the facilities of assembly room and hotel.

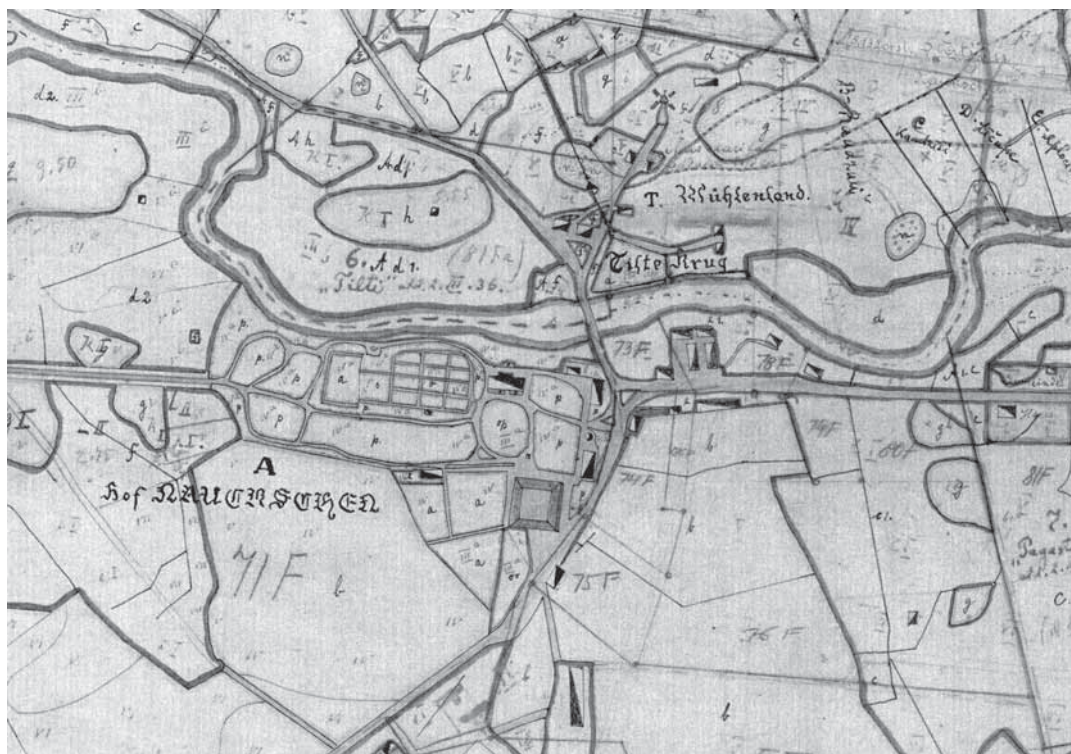
Figure 4.
The land plan of the manor. 1904. (Latvijas Valsts vēstures arhīvs)

In 1880 F. W. von Grote sold the manor to his cousin landrat Alexander Michael Andreas Maria von Grote (1829-1917). The land plan of 1904, *Karte des im Wolmarschen Kreise Rujenschen Kirchspiele belegen privaten Gutes Naukschen*,⁴ shows the construction of the central part of the manor from the period when the Grotes managed the manor over the last decades (Figure 4). The plan is a copy of revision made by E. Kristiani in 1865 -1869 and the revised plan by R. R. Jacobsen in 1880 and 1881. The plan shows the whole household complex of the manor with its peasants' farms, borders of the land and other. The living and household buildings were situated in the center of the manor round the yard, including the manor house, the stable with a shed, the barn with a cellar, the cheese dairy, and the cattle-shed somewhat further away. A round entrance road was situated in front of the manor house, and there was a park along the river towards the family chapel.

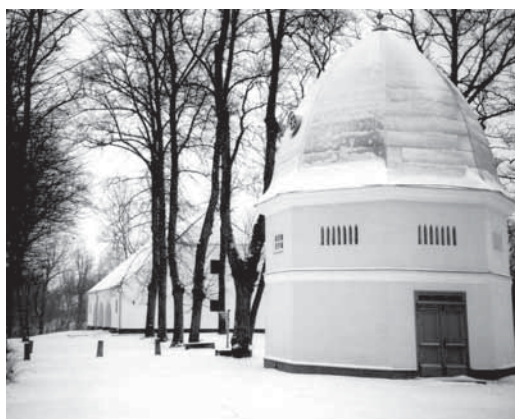
Figure 5.
Cheese dairy (Photo by Zilgalvis)

One of the buildings is a cheese dairy, or a *watchtower*, that can be seen already in the draft of J. K. Brotze of 1800. It has maintained its original exterior until nowadays (Figure 5). The second building is a barn, which is not presented in the land plan of the manor of 1695, but it is present

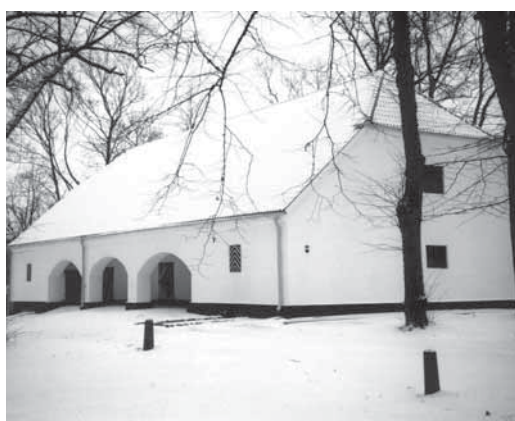
Figure 6.
Barn (Photo by Zilgalvis)

in the draft of J. K. Brotze of 1800. Judging by the size of the spatial structure, the building is constructed in the middle or the last quarter of the 18th c (Figure 6.)

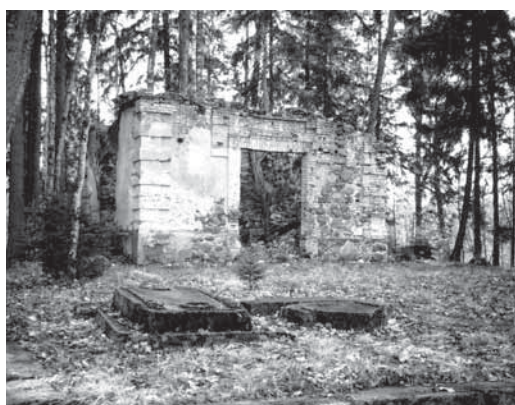
Figure 7.
Masters graveyard and chapel (Photo by Zilgalvis)

A master's graveyard and a chapel have been present in the location since 1793. The land survey of the 19th c. dates the building in evidence of this presence. The graveyard was destroyed in 1944 with the Red army entering the country. The chapel has survived in the form of the ruins, which are now an important element of the park. (Figure 7).

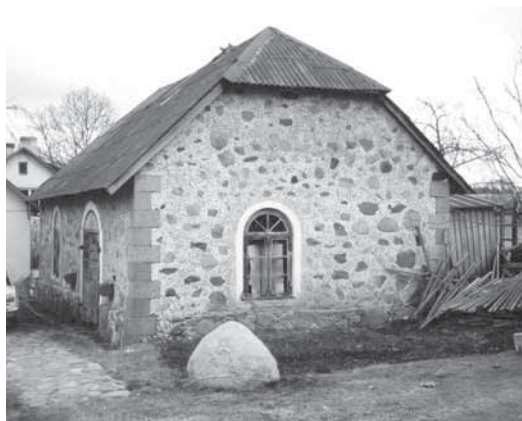
Figure 8.
Smithy (Photo by Zilgalvis)

henhouse. Drawing on the information provided by local people, the building housed a smithy. This function is more likely to be true judging by the look of the building (Figure 8). A household building right behind the smithy along the road was marked as a shed and a brewery in the plan of 1922. The building underwent significant reconstruction in the course of time, which is clearly seen in the plan of 1904.

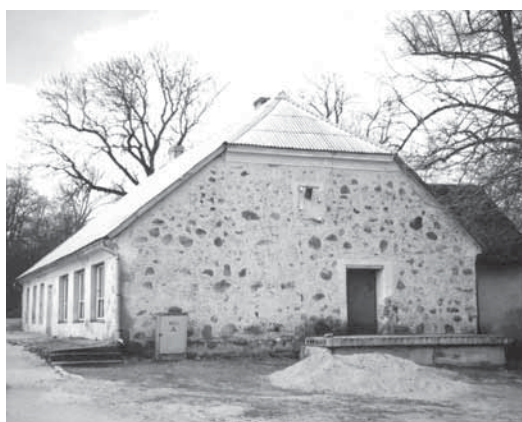
Figure 9.
Farm labourers' house (Photo by Zilgalvis)

Several houses of farm labourers are seen today in their initial places as marked in the plan of 1904. They have maintained their original appearance. Most of them are likely the buildings from the middle of the 19th c (Figure 9).

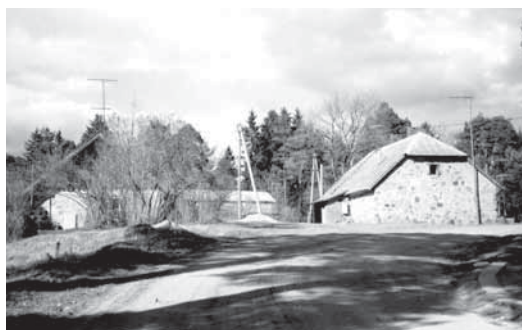
Figure 10.
The group of mill buildings (Photo by Zilgalvis)

The further building pattern of the manor can be divided into two groups – one of the mill and another of the brewery. The group of the mill shows some buildings that were used for dwelling in 1922. There is a wooden shed, built on the foundations of boulder masonry behind this building. Opposite to this building on the other side of the road is a log building marked as a twin barn. It is impossible to determine the connection of the barn with one or another building on the site (Figure 10). According to the plan of 1904, further at the end of the road was a windmill which has not survived until nowadays. Instead of the windmill, there is a masonry household building in this place today, which can be dated to the middle of the 19th c. There are two living houses right in front of the mill on both the sides of the road. These buildings were already marked in the plan of 1904. They functioned as typical servants' houses.

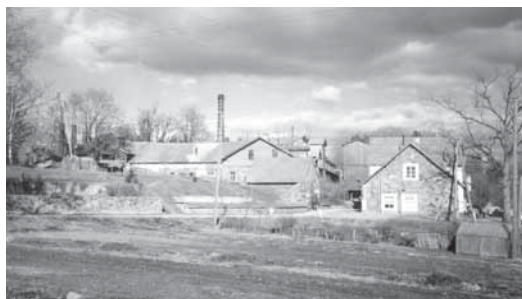
Figure 11.
The group of brewery buildings (Photo by Zilgalvis)

The group of brewery buildings includes several objects. The most important is the brewery itself located round the yard to create a complex characteristic to industrial heritage (Figure 11). These are the buildings typical of the architecture of the end of the 19th c – the beginning of the 20th c. The buildings are not marked in the plan of 1904. They were most likely constructed in the end of the first decade of the 20th c. There is a single masonry building, most likely constructed much earlier, in the brewery group on the riverside.
