TRANSPORT MEANS 2018

PROCEEDINGS OF THE 22nd INTERNATIONAL SCIENTIFIC
CONFERENCE

Vibro Acoustic Measurement at Sea: How Predictable Are Motor Failure by Means of Vibration Measurement?

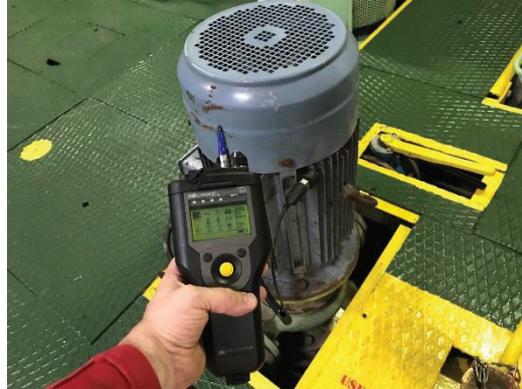
Fig. 1 Test object

Centrifugal pump electric motor (Fig. 1): Nom. Rev – 3515rpm, Real rev. – 3565rpm, Current – 33.5Amp, Power – 21.4kW, bearing in use: 2 X SKF 6309 2ZC3 (Single row deep groove, two side metal shield, radial clearance larger than normal), 45mm I.D, 100mm O.D

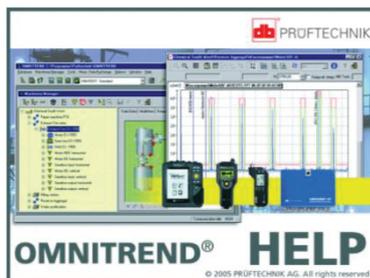
Fig. 3 Omnitrend 2.91.advert

For measured data analyse manufacturer: Pruftechnik AG software: Omnitrend 2.91.was used (Fig. 3). Centrifugal pump electric motor condition has been analysed at period as per below Table 3.

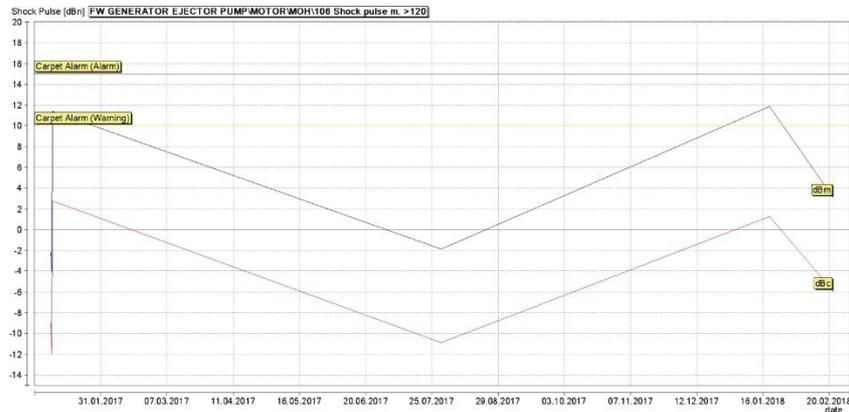
Fig. 9 MOTOR\MOH\106 Shock pulse $m. > 120$

Fig. 9 Shock pulse $m. > 120$ indicate that on 19.01.2018 carpet and max values have increased to above the alarm thresholds what means that there is clear problem with outer end bearing. Further this problem are analysed by 1005 VSC R.b.env. 60K6400 data collection.
