# MECHANIKA 2017

PROCEEDINGS OF THE 22nd INTERNATIONAL  
SCIENTIFIC CONFERENCE

# Assessment of Technical Condition of 2M62 Locomotive Bogie Frames and Bolsters using Acoustic Emission Method

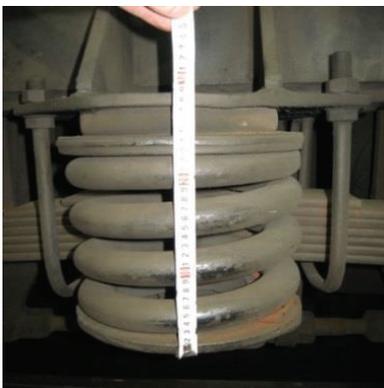
Fig. 1 Measurement of spring preload to calculate the loads

Test programs on the stand and on-the locomotive selected identically. The difference - in the extreme force: on the stand, it exceeds the maximum operating weight of the body of the locomotive is 10%. The locomotive is fitted to the depot to four power jacks, which are designed for lifting locomotive body. Measured compression springs with the full weight of 100% workload (Fig. 1).

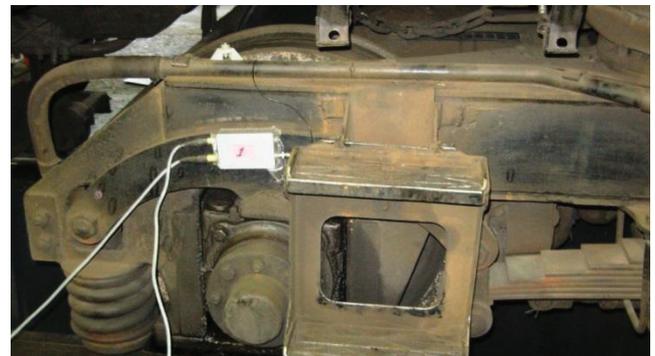
Fig. 3 Control sensors attachment on the bogie frame of the locomotive

of the top sheet of the lateral beam of bogie frames as it shown in Fig. 2 and Fig. 3.

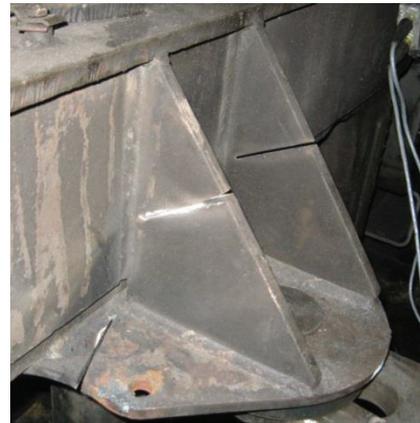
Fig. 8 Cuts concentrators corresponding to the first stage of loading

visually, the bogie frame test structure was modified through a step-by-step introduction of the cut concentrator in one of the power units of the frame supports as shown in Fig. 8. It has been made for the early appearance of a fatigue crack.

From this moment on the test carried out in four stages. The first stage was carried out in a number of concentrators cuts in gussets and at the base of the power unit support frame. In the second phase concentrator cuts in power unit support gussets added. In the third stage of the power unit support gussets were cut off. In the fourth stage, it was performed cut in the corner area of the power unit support.

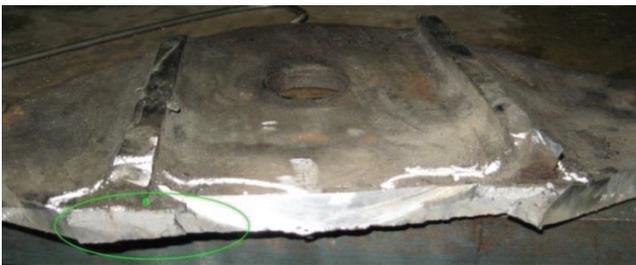
Fig. 11 The final break in the concentrator cutting zone at the base of the corner bearing frame

Since its introduction of the first series of cuts the character of the plots of sum of AE and its intensity changed. Figs. 13, 14 show dependency of sum and the intensity of the AE over time since the start of the test in the presence of concentrators until fracture of the frame near cuts (Figs. 11, 12).

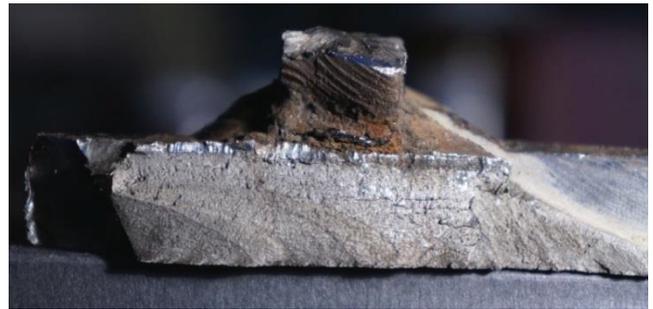
Fig. 12 Fracture relief, where the growth of a fatigue crack began
