Restoration of masonry arch bridge over Venta River in Kuldiga

Andris Paeglitis, M.Eng. Ph.D.student, Riga Technical University, Address: Azenes st. 20, Riga, LV1048, Latvia. E-mail: andris.paeglitis@inzenierbuve.lv

Ainars Paeglitis, Professor , Dr.sc.ing., Riga Technical University, Address: Azenes st. 20, Riga, LV1048, Latvia. E-mail: paeglitis@apollo.lv.

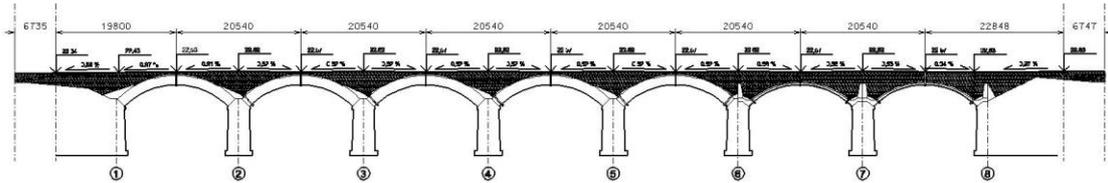
Fig.8: Longitudinal section of the bridge

For the bridge to be able to carry the transport capacity provided by transport rules, a reinforced concrete slab resting on a ground filling of arches will be put on the top of brick arches. This slab provides not only some bearing capacity and load distribution but also helps to collect and drain water from the deck (Fig.8). Side and piers of arches will also get restored. It is planned to renew the present electricity poles, to make four new ones (the analogues), as well to reconstruct the system of technical support system. A very modern lighting system will be built.

After renovation it will be possible to use the bridge over the River Venta for everyday traffic capacity provided by transport rules (Fig.8).
