CONCRETE BRIDGE DETERIORATION CAUSED BY DE-ICING SALTS IN HIGH TRAFFIC VOLUME ROAD ENVIRONMENT IN LATVIA

Kristaps Gode¹, Ainars Paeglitis²✉

Institute of Transport Infrastructure Engineering, Riga Technical University, Kaļķu str 1, LV 1658 Riga, Latvia

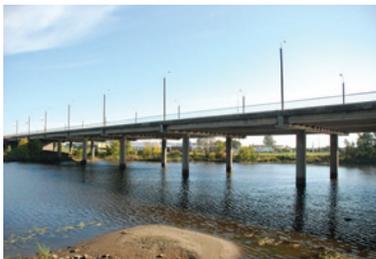
Fig. 4. Bridge over Biekēngrāvis

The bridge over Biekēngrāvis is situated on the left side of the river Daugava in the municipality of Riga and is part of the Salu Bridge complex (Fig. 4). Bridge has six traffic lanes, speed limit of 70 km/h and traffic volume of over 60 000 vpd. The bridge consists of 15 simply-based prestressed girder (bulb-tee beam) spans (concrete class M450) and is 384.7 m in length. This bridge was constructed in 1973.

The bridge above each pier has two joints, which are the weak point of these type structures (Fig. 5). Leaking joints may cause reinforcement corrosion damage to cap beam and tail-end parts of the prestressed bulb-tee beams.

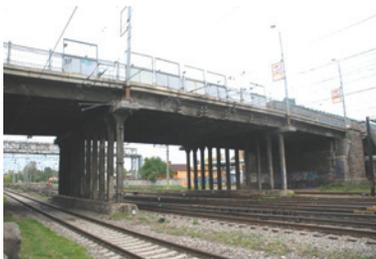
Fig. 6. Bridge over the railroad ("Gaisa tilts") in Riga

This bridge is situated in municipality of Riga, where continuation of highway A2 enters the city centre. The bridge has only two lanes of traffic and two tram lines, which are used as a third traffic lane during rush hours. The speed limit is 30 km/h and traffic volume is over 35 000 vpd. The bridge consists of three simple beam spans which overpasses five railroad tracks (Fig. 6). The superstructure and the middle span piers were built in 1963, whereas the masonry stone abutments were built in 1906. The side spans have 13.24 m long reinforced concrete T-beams (concrete class M300); the middle span has 16.76 m prestressed concrete beams (concrete class M400). The waterproof membrane beneath tram lines has been deteriorated and beams (especially side span beams) are exposed to moisture and de-icing salts.

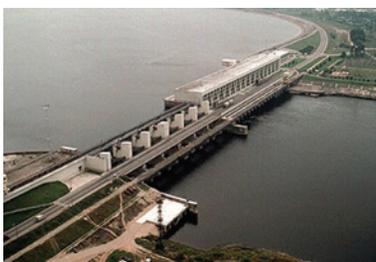
Fig. 7. Bridge over the Daugava River near the hydro power plant

This bridge is situated on the Riga bypass highway A5 (Fig. 7). The bridge is located beside a hydro power plant "Rigas HES" and has two lanes of traffic with of over 10 000 vpd. The bridge was built in 1973. The superstructure of the investigated bridge consists of six 24 m long spans; each span has six prestressed concrete bulb-tee beams of 450 kg/cm² compressive strength at 28 days (concrete class M400). Above each pier there is one expansion joint.

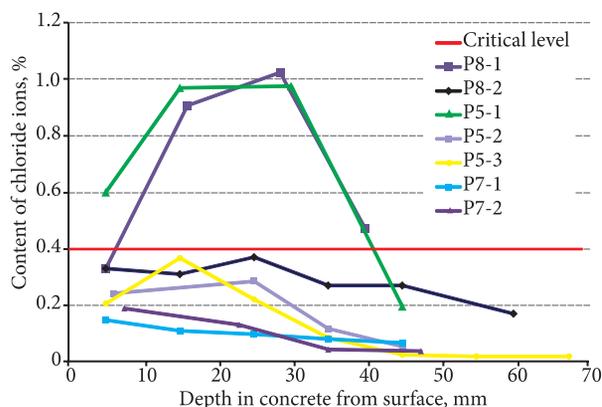
The samples were cut at 10–15 mm intervals and the pieces were examined for chloride content in compliance to *LVS EN 196-2:2013 Method of Testing Cement. Chemical Analysis of Cement*. The amounts of chlorides in the concrete samples, are presented in the chloride profile shown in Fig. 11 (one point describes chloride concentration in one piece of concrete).

Fig. 11. Chlorides in cement paste of bridge piers

Fig. 14 shows that the amounts of chlorides vary greatly at different depths in concrete and in different places of the structure. In depths under about 15 mm the chloride content is low. This shows that chlorides closer to the surface were washed out. The profiles with the highest chloride concentration (samples P8-1 and P5-1) were found from surfaces facing toward the traffic direction and closer to the corner of the pier.

The profiles (P8-1 and P8-2) from the approach ramp No. 8 piers were obtained from the same surface facing towards traffic. Profile P8-1 shows much greater chloride concentration, because it is much closer to the road. At the reinforcement depth 42 mm the chloride concentration is close to critical value of 0.4%. Since no corrosion was detected, it is assumed that reinforcement corrosion threshold value is at least 0.4% or greater. Both profiles and the fact that there are reinforcement corrosion cracks at the pier corner, which is the closest to highway, show that chloride distribution is greatly influenced by the distance

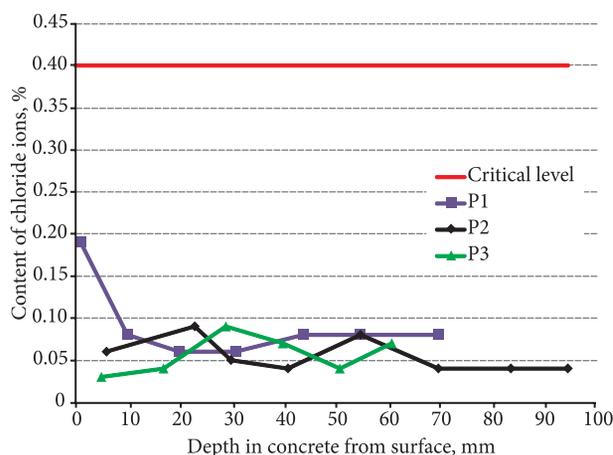
For the bridge over Biekengrāvis we investigated corrosion initiated by de-icing salts that reach structure surfaces through leaking expansion joints. The core samples (Fig. 12) were obtained from the web of the beam near the tail end of it (sample P2 and P3) and from the cap beam side surface bellow the leaching joint (sample P1). The chloride profiles from obtained samples are shown in Fig. 13. The investigated web part of the beam did not have significant moisture signs. It was technically impossible to take the sample at very tail end of the beam, which might have a higher moisture exposure. The investigated cap beam surface that is located below expansion joint has been exposed to moisture and de-icing salts.

Fig. 13. Chloride profiles for the bridge over Biekengrāvis

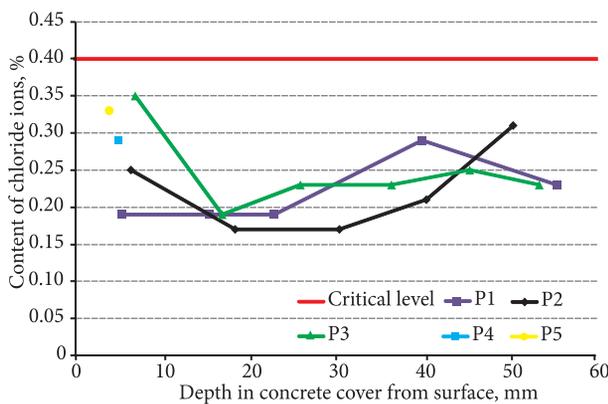
Fig. 18. Chloride profiles for bridge over the river Daugava on bypass A5

As this bridge has leaking expansion joints, samples P1 and P2 were obtained from the tail end of the beam near a leaking joint where moisture was obvious (Fig. 16) and samples P3, P4, P5 from the position where no moisture or chlorides (signs) were present (Fig. 17). The inspection also took place at the end of the summer season where most of the chlorides from the surface were washed out. The samples were obtained by concrete drilling at different depths from the surface and collecting the concrete powder. The obtained chloride concentrations and chloride profiles are shown in Fig. 18.

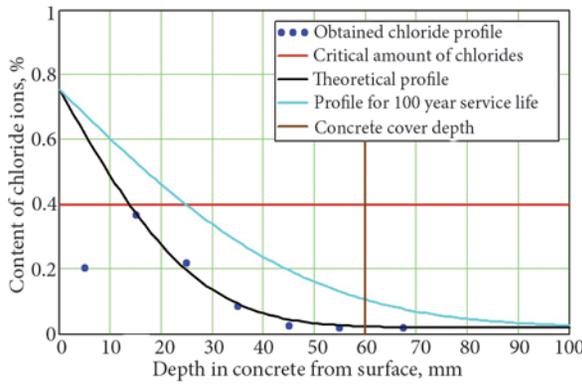
The profile P5-3 corresponds closely to the theoretical profile (Fig. 19). The future profile for 100-year service life is calculated by extrapolation. Fig. 19 shows that the critical concentration of chlorides at which it is assumed that corrosion starts has not reached the depth of reinforcement.

Fig. 19. Calculation of chloride profiles (profile P5-3) at deterministic level

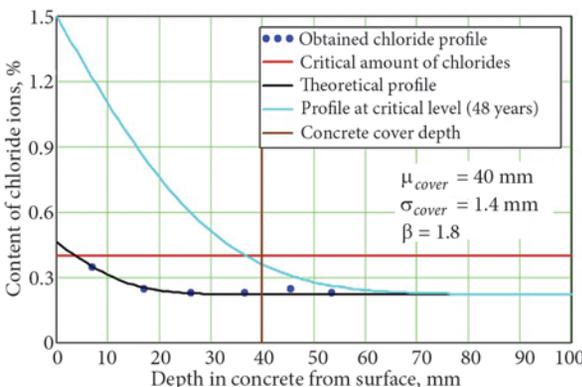
Fig. 20. Calculated chloride profile for 40 mm concrete cover in a case of a higher chloride exposure

performed at a semi-probabilistic level with reliability index β value of 1.8. In addition, the service life calculations were performed for a case of damaged and leaking waterproof membrane or expansion joints where high concentrations of chlorides reach superstructure surfaces.
