Pavels GAVRILOVS*, Viktors IVANOVS

Riga Technical university, Institute of Railway Transport
Azenes street 12, LV-1048, Riga, Latvia

RESEARCH OF THE DEFECTIVE FROG WING OF 1/11 MARK

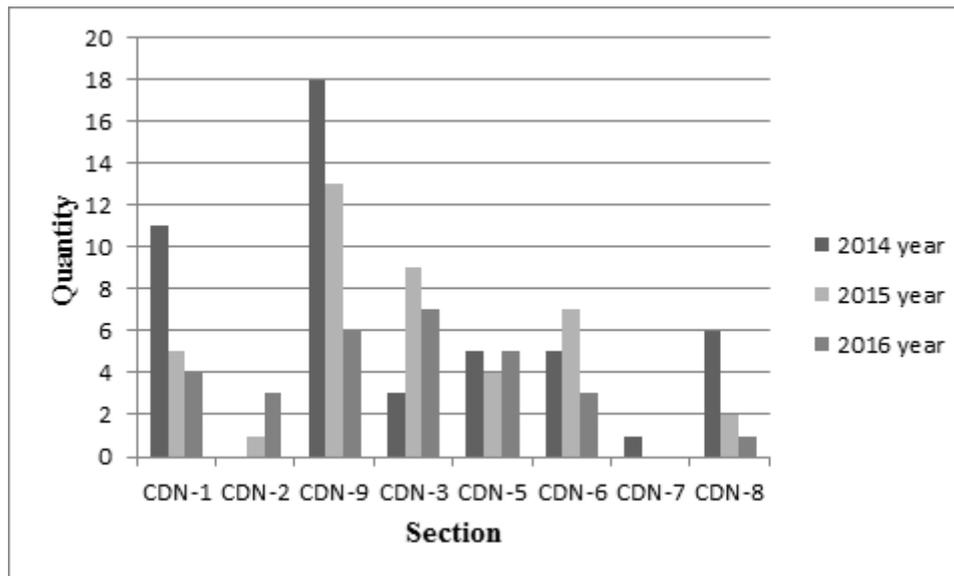
Fig. 1. Incidence of defective frog elements from 2014 to 2016

It follows from the diagram (Fig. 1) that, in 2014, the greatest number of rail defects was found in the CDN-9 Riga Department (18) and rail defects were not found in the CDN-2 Ciekurkalna Department. In 2015, 13 points defects were detected the Riga Department. Rail defects were not found in the CDN-7 Lepay Department for the whole year. In the previous year, 2016, the number of rail defects was reduced; in particular, only 7 rail defects were found in the CDN-3 Daugavpils Department. Rail defects were not found in the CDN-7 Lepay Department for the whole year.

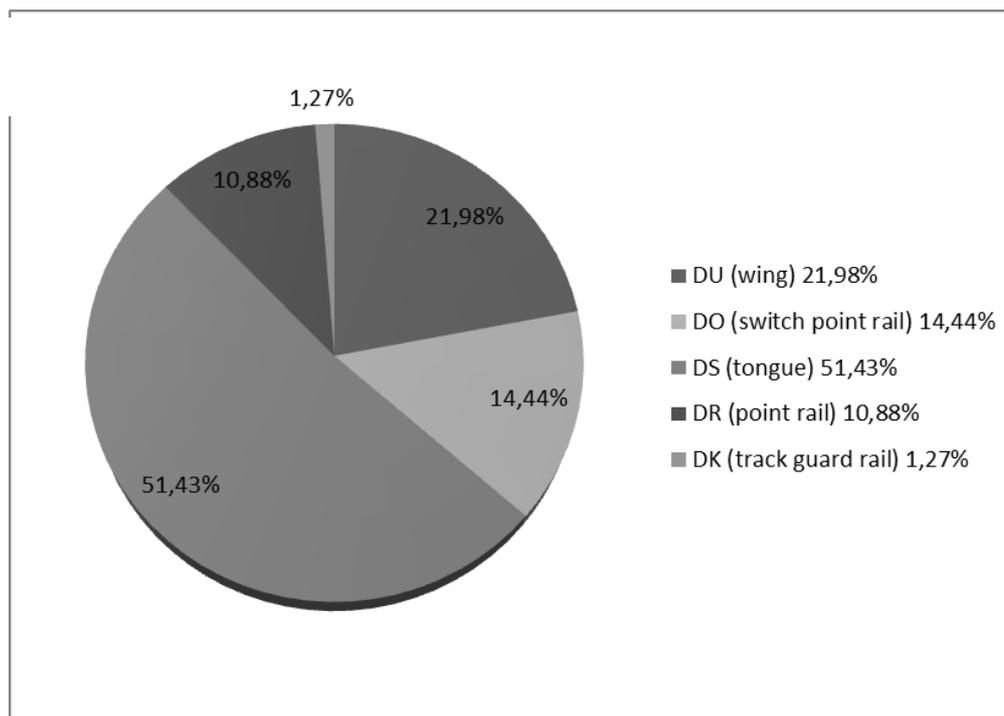
The analysis of the statistics of the defects of point switches that had been carried out on the railways network of JSC RR [2] showed that the greatest numbers of defects were detected in the tongues of frogs of point switches. The distribution of defects by the elements of the point switches is shown in Fig. 4 [8].

- Defects of the wing (21.98%);
- Defects of switch point rails (14.44%);
- Defects of the tongue (51.43%);
- Defects of the point rail (10.88%);
- Defects of the track guard rail (1.27%).

Fig. 4. Distribution of defects in point switches in the places of their formation in %
